**ENVIRONMENTAL SITE ASSESSMENT (ESA) – PHASE I**

Property located at 199 Grant Street in Carleton Place, ON

**O/Ref.: 20381**

RE:           **ENVIRONMENTAL SITE ASSESSMENT (ESA) – PHASE I**  
                  Residential Building  
                  Property located at 199 Grant Street in Carleton Place, Ontario

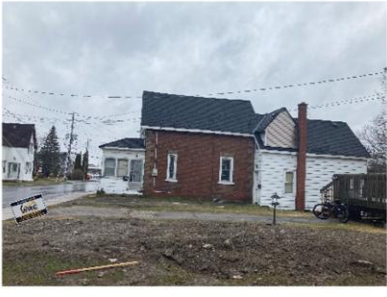
| SECTOR DETAILS | | |
|---|---|---|
| Adjacent Site to the North: | <p>Residential building located at 193 Grant Street</p> | None |

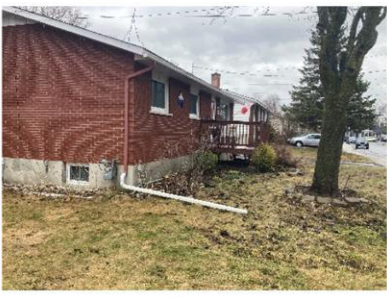
| SECTOR DETAILS | | |
|---|---|---|
| Adjacent Site to the South: | <p>Residential buildings located at 207 Grant Street</p> | None |

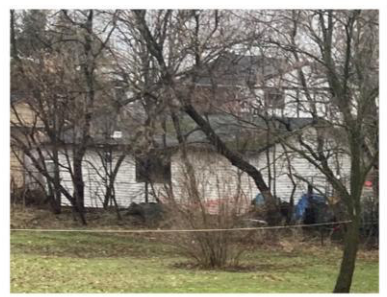
| SECTOR DETAILS | | |
|---|---|---|
| Adjacent Site to the East: | <p>Residential building located at 202 Franktown Road</p> | None |

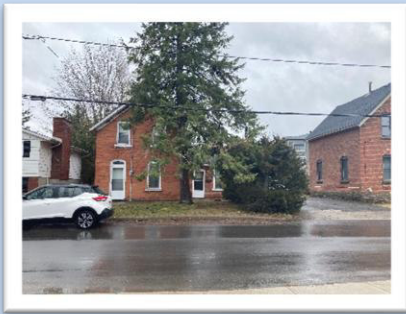
| Adjacent Site to the West: | <div></div> <div>Residential building located at<br/>202 Grant Street</div> | None |

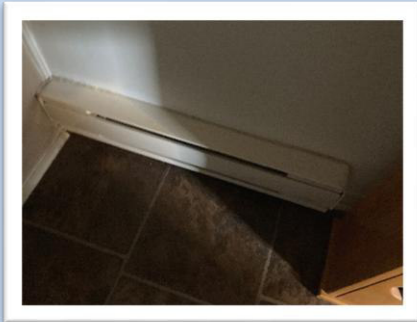
| RESULTS OF THE SITE VISIT | | CONCERN(S) |
|---|---|---|
| Heating system | <p>Electric Baseboard</p> | None |

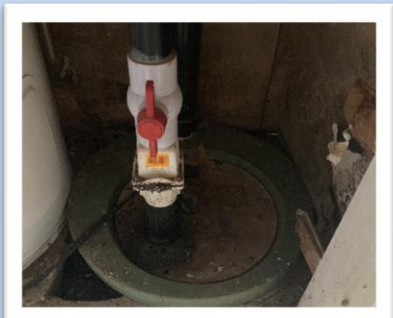
| RESULTS OF THE SITE VISIT | | CONCERN(S) |
|---|---|---|
| Sump | <p>One (1) sump pump<br/>No signs of contamination were observed.</p> | None |

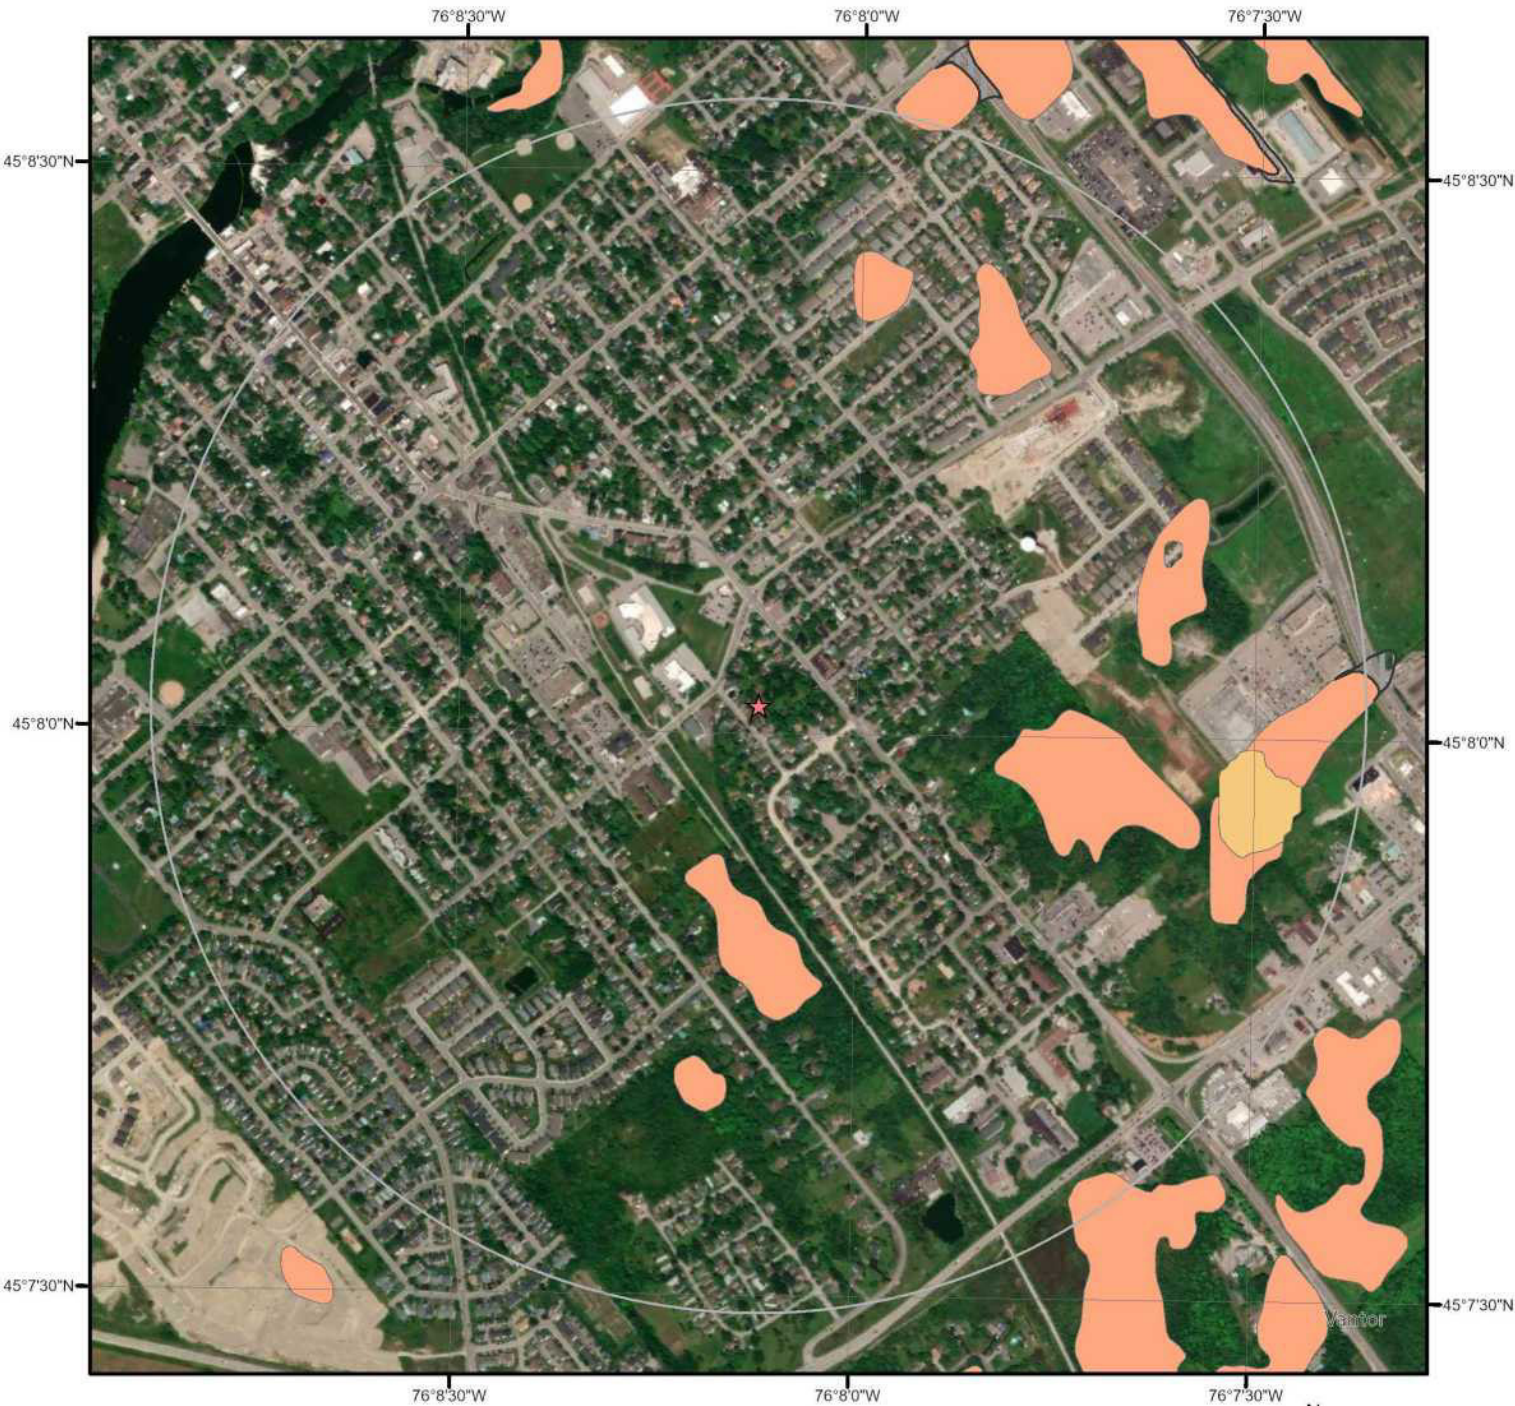
Wetland

This map shows wetland existence. Data coverage is shown to the right. Gray indicates no data available in the area.
